EQUIPMENT CONDITION INVENTORY	
BUILDING ASSESSMENT	
D.C. DEPARTMENT OF GENERAL SERVICES	
LINCOLN THEATRE 1215 U STREET, N.W. WASHINGTON, DC PO388329	
TYPE OF EQUIPMENT	: Main Switchboard
LOCATION	: Basement Electrical Room
IDENTIFICATION NO.	: MSB
MANUFACTURER	: General Electric
NO. OF CUBICLES	: 7 Sections
EQUIPMENT CONDITION CODE <small>RED: Poor condition. Severe deterioration. YELLOW: Marginal condition. Moderate deterioration. GREEN: Acceptable condition. Limited deterioration.</small>	
CODE	: Green
AGE (YRS)	: 20 years
TYPICAL USEFUL LIFE (YRS)	: 50 years
REMARKS : Ammeter not functioning. GE#72298872; Plant # T222 Inspected by Kolb Electric 4/5/04

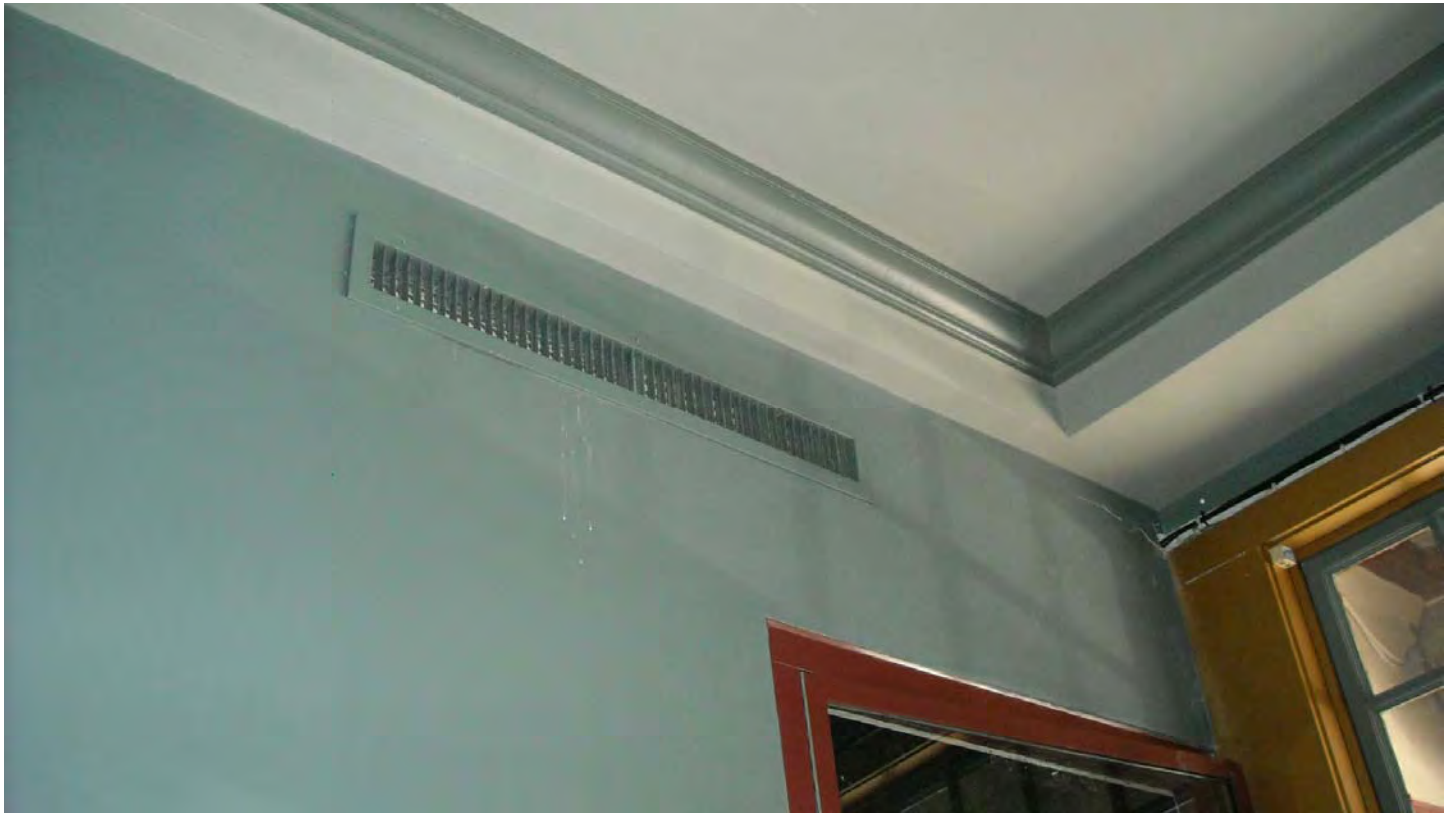
Pic 1 – Supply Air Grille

Each of the two vestibules is heated and cooled by a 36 x 4 ceiling grille. Location and size of the grille is not deemed adequate to heat the vestibule.

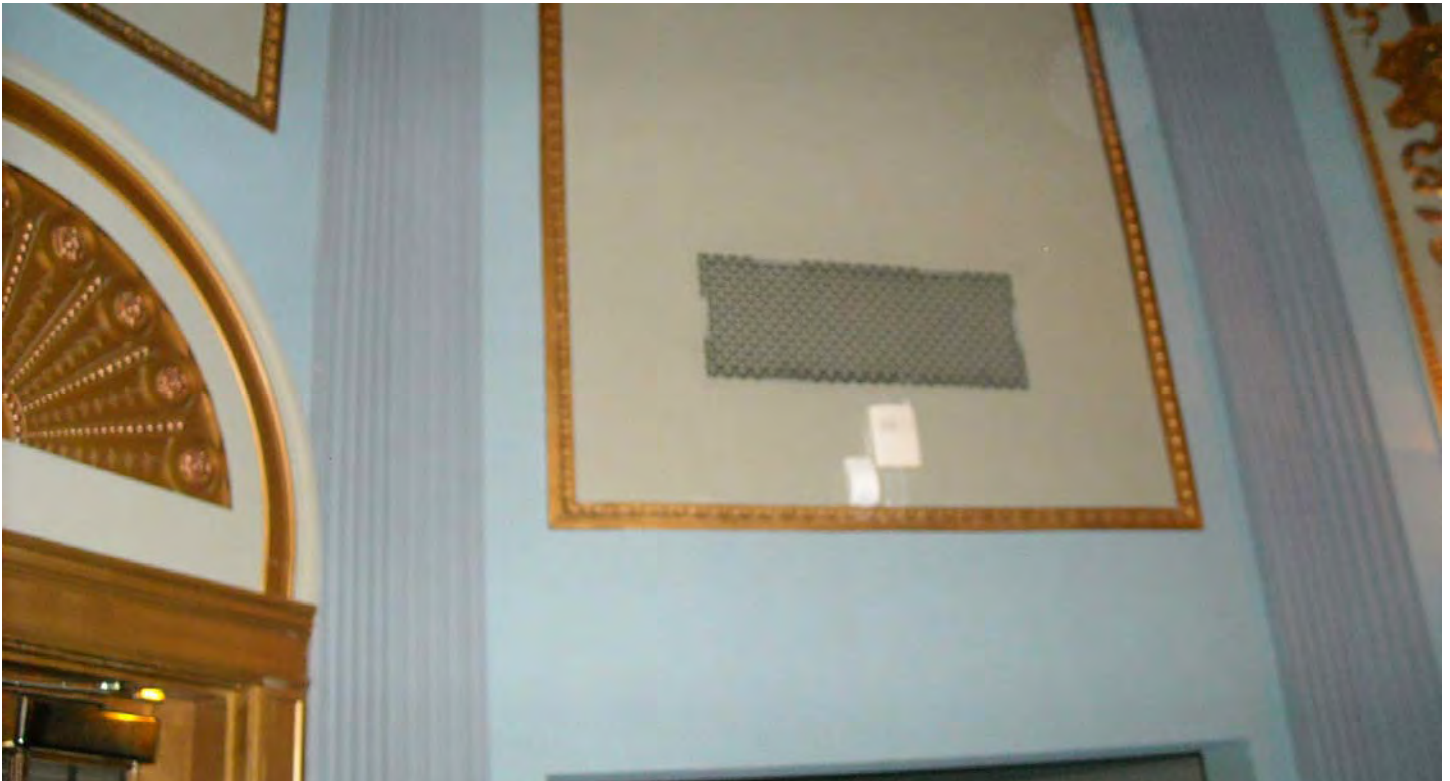
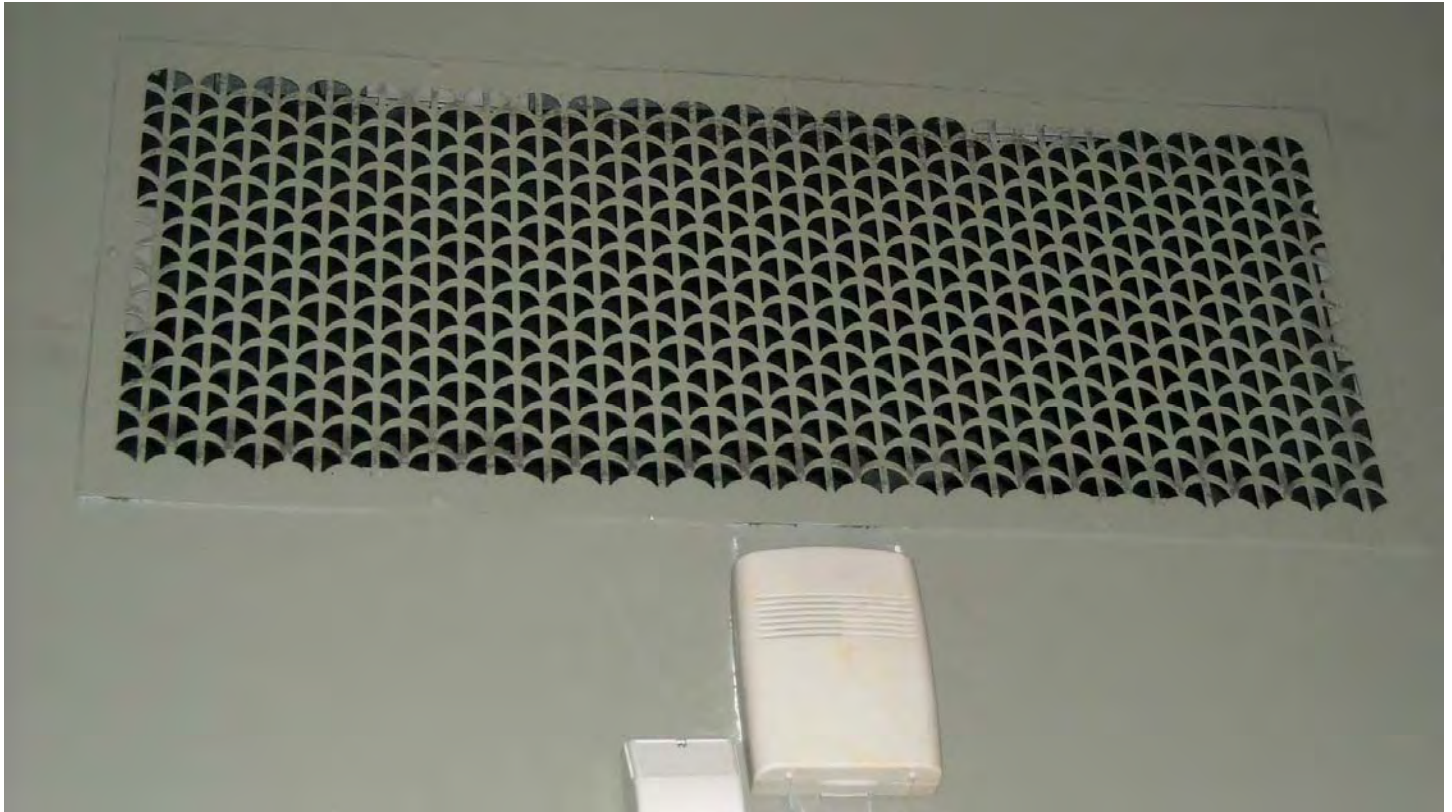
The 2007 renovation replaced the foyer AHU with a DX packaged gas-fired rooftop AHU (RTU-2). The design documents (12/29/06) neither indicate the existing air distribution system nor indicate an air balance to be conducted to assure proper airflow to the various air terminals.

Furthermore, the type of supply grilles used do not offer the devices require to achieve proper air throws and room coverage. The result is minimal coverage in the immediate vicinity of the grille with all the heat rising to the ceiling level.

Pic 1- Foyer Supply Grille

Pic 2- Foyer Supply Grille

1. Develop drawings to show the complete duct distribution inclusive of the newly replaced RTU-2.
2. Commission RTU-2 to assure it operates at its design capacity.
3. Perform a preliminary air balancing report to establish degree of effectiveness of delivery air to the areas served.
4. Analyze results and determine degree of modifications based on the documented air measurements

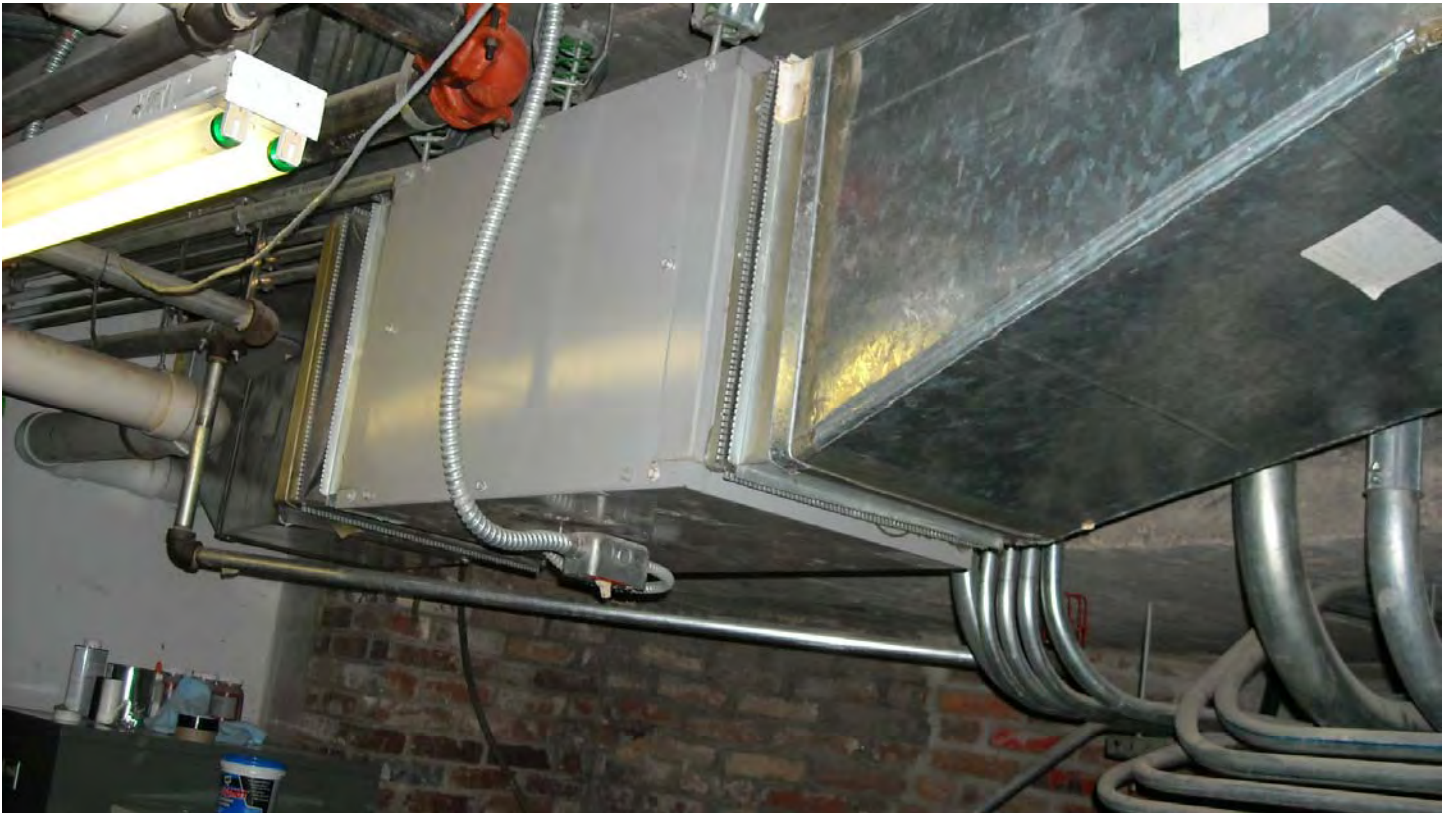
In-line supply air fan serving main electrical room not working.

Repair or replace with new in-line supply air fan.

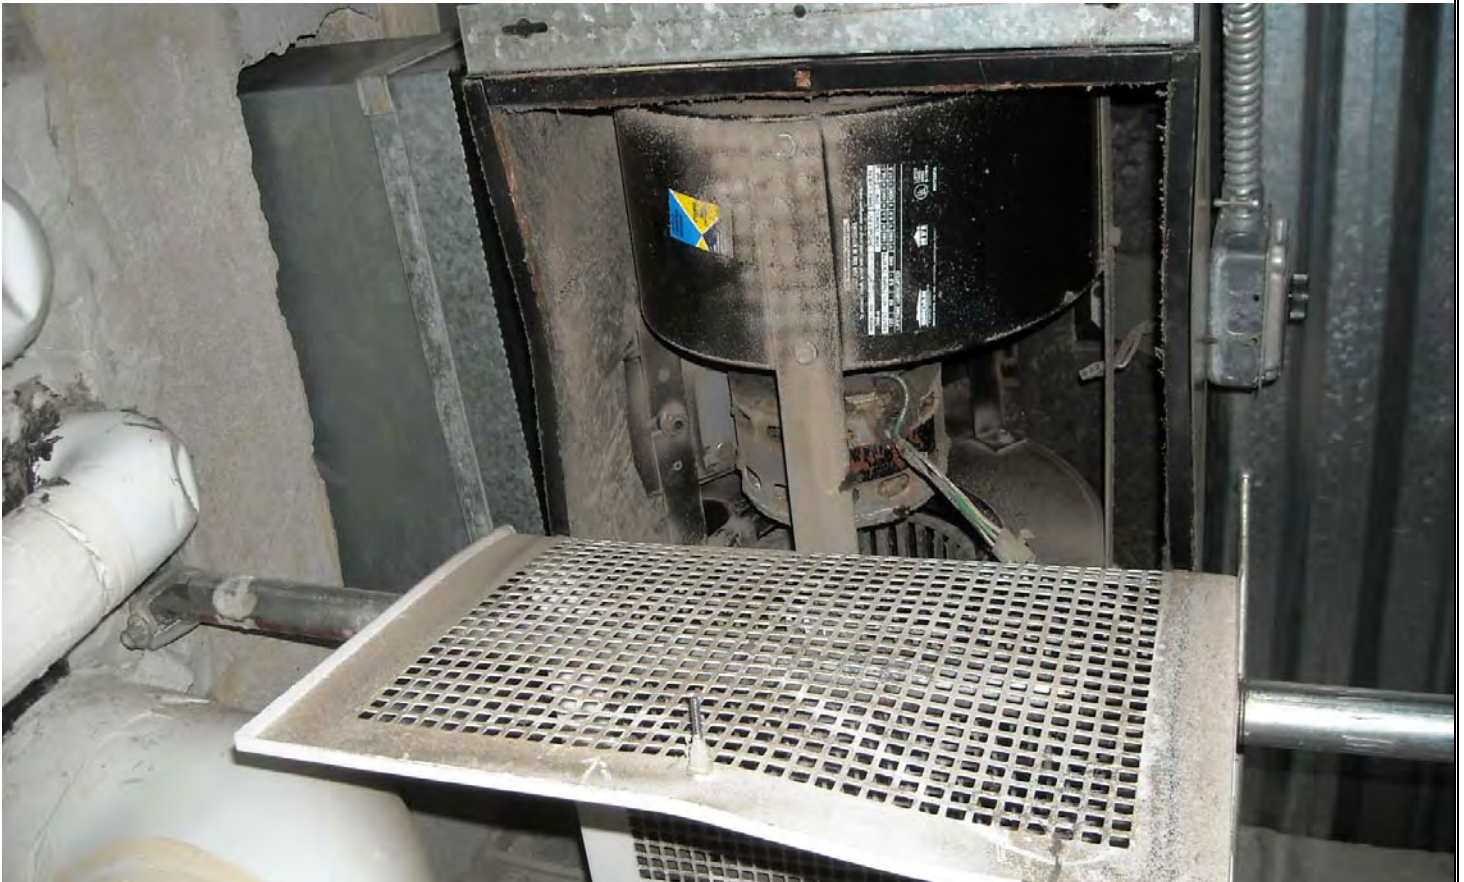
In-line exhaust air fan serving gas meter room is not working.

The exhaust air fan has exceeded its useful life and shows severe deterioration. Replace with new in-line exhaust air fan.

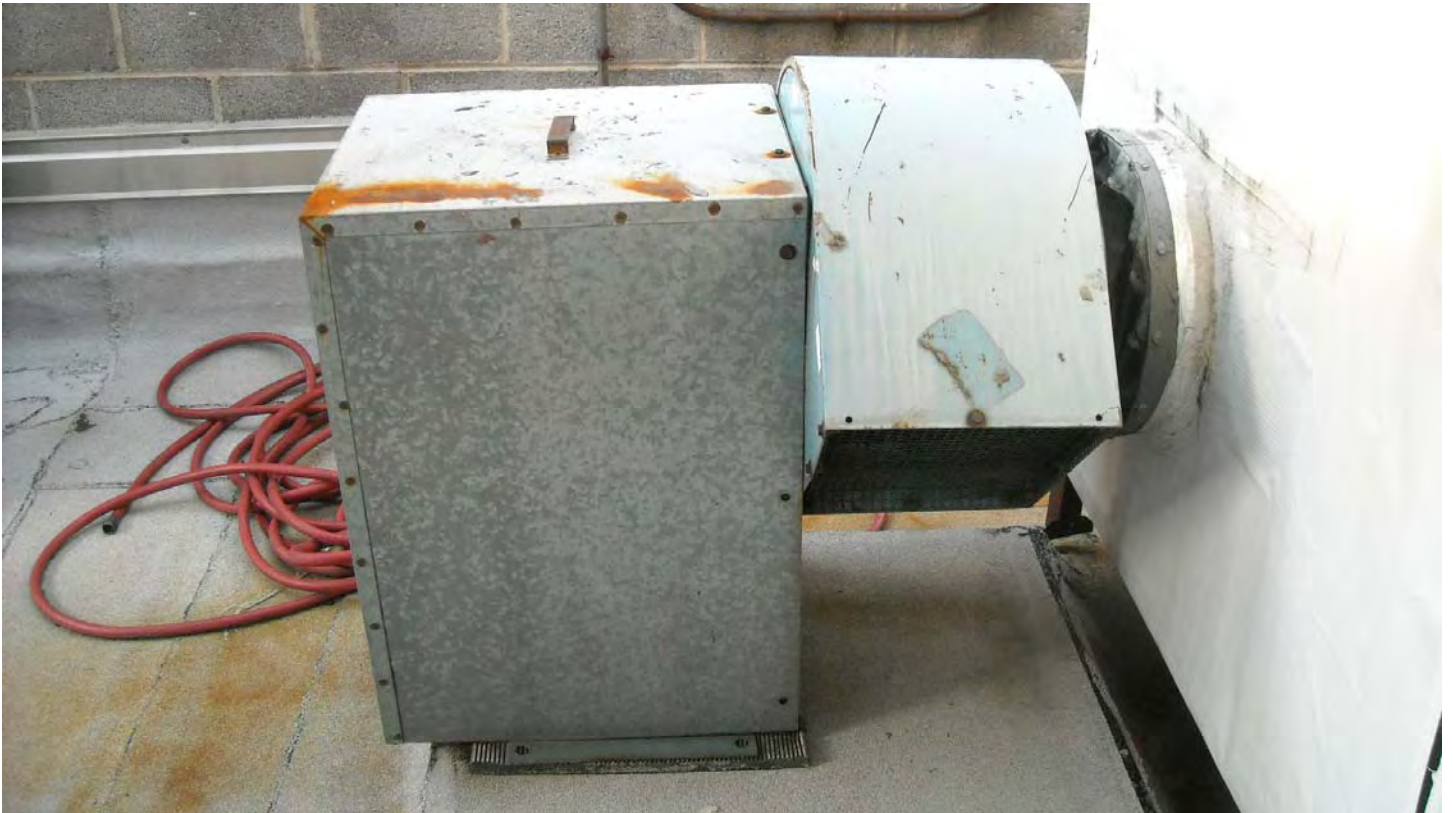
Centrifugal utility exhaust air fan located on dressing room roof (low roof) serving bathroom and dressing room is in poor condition.

The exhaust air fan has exceeded its useful life and shows severe deterioration. Replace existing exhaust air fan with new and balance entire system.

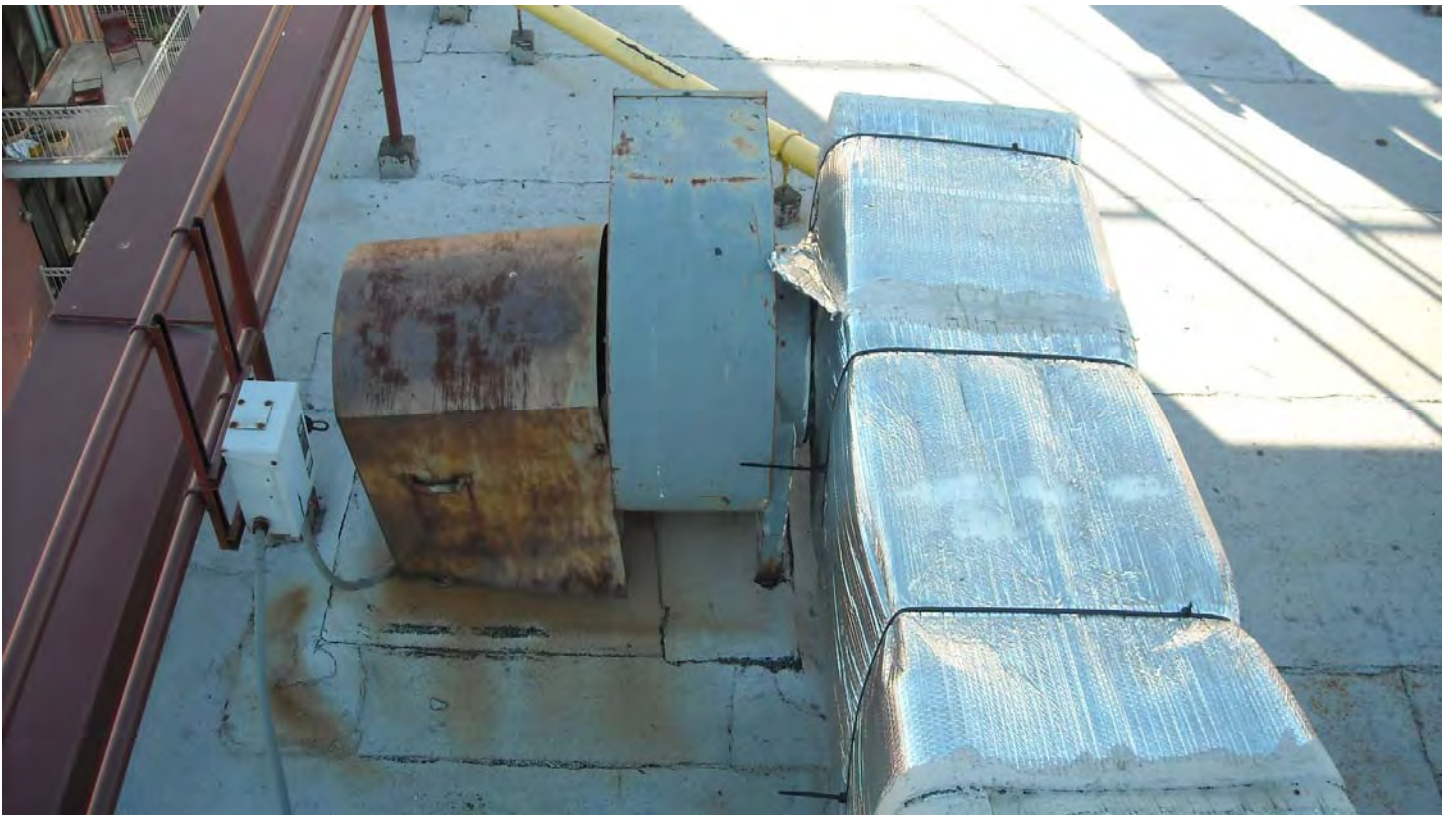
Centrifugal utility exhaust air fan located on stage roof is in poor condition.

The exhaust air fan has exceeded its useful life and shows sever deterioration. Replace existing exhaust air fan with new and balance entire system.

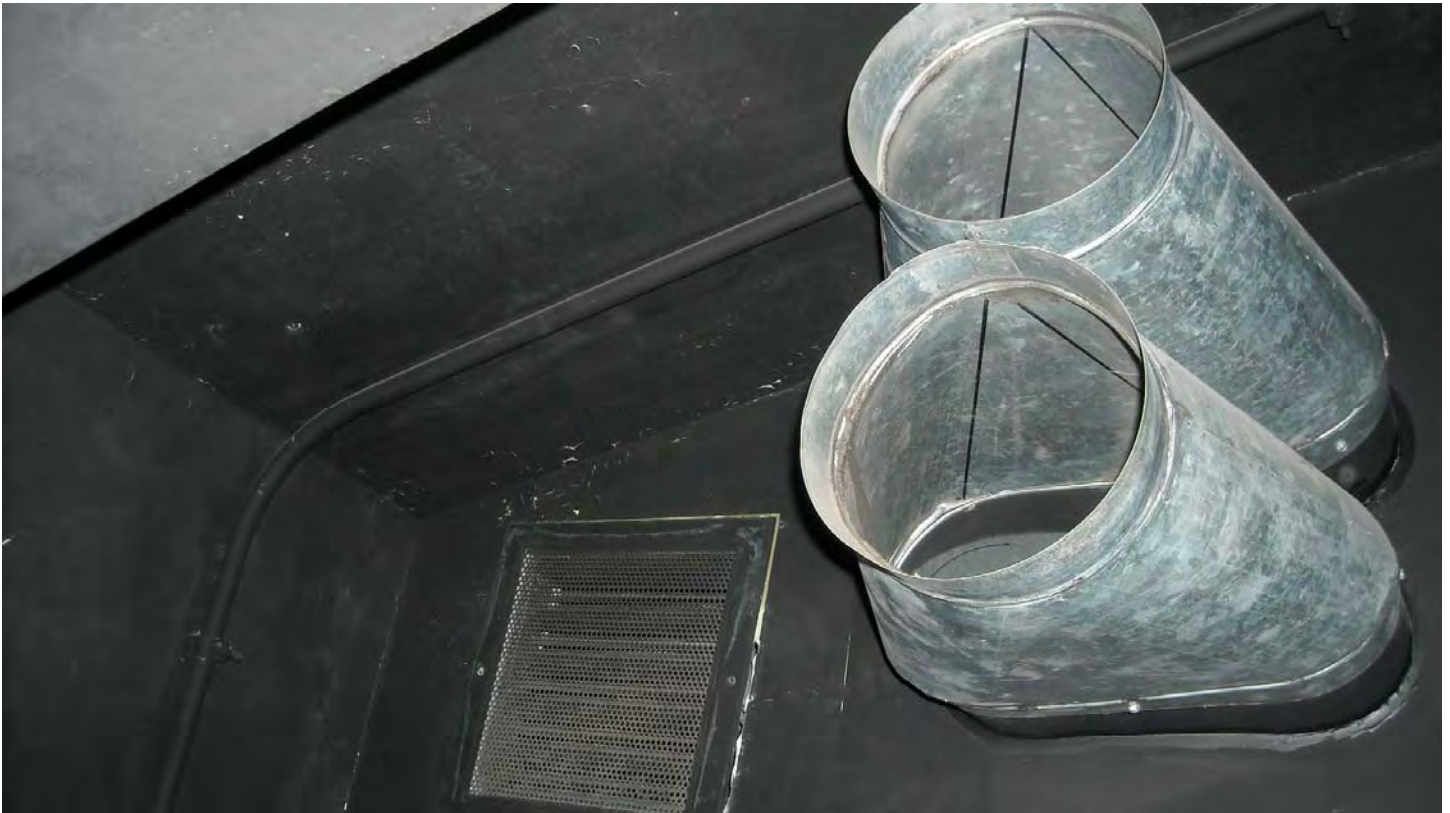
The exhaust air fan serving projector room and ductwork is in poor condition.

Repair/replace exhaust air fan with new. Modify ductwork as needed and balance to design air quantity.

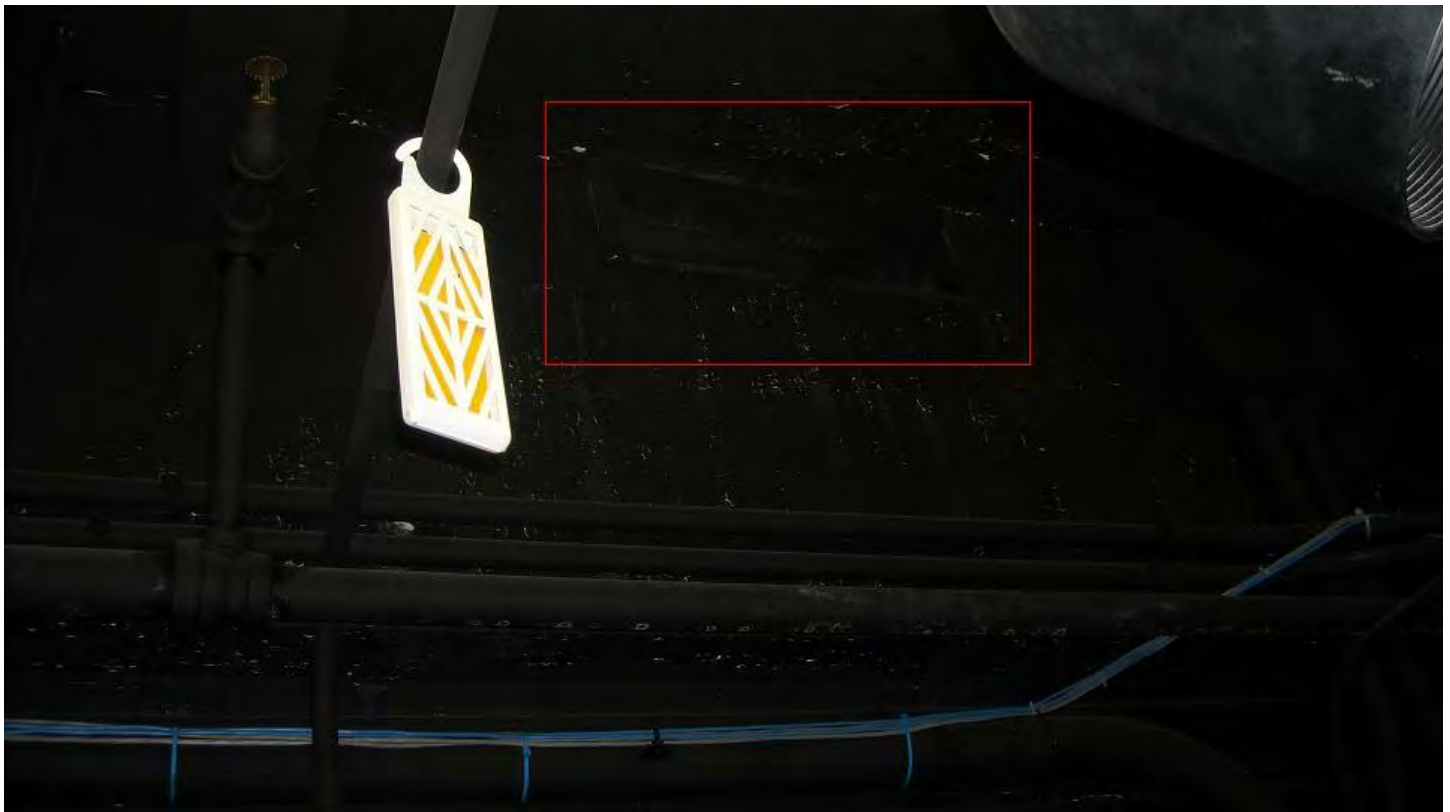
Supply air ductwork serving projector room in need of top register and volume damper.

The supply air ductwork serving projector room is missing top register. Supply air duct shall be extended and provided with volume damper and register.

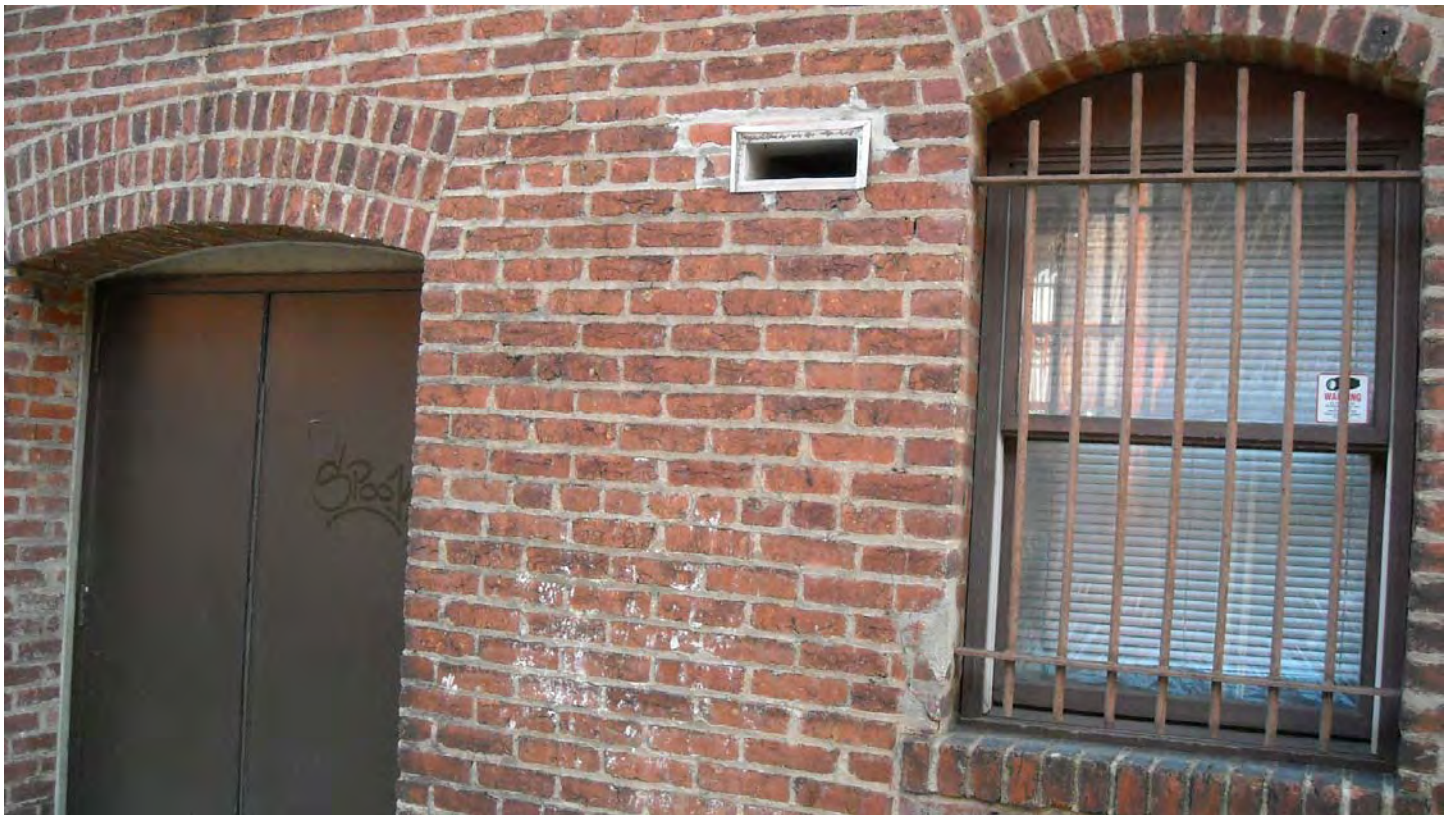
The exhaust wall cap protecting the in-line exhaust air fan outlet on west wall is missing.

Provide wall cap to protect duct/fan from weather.

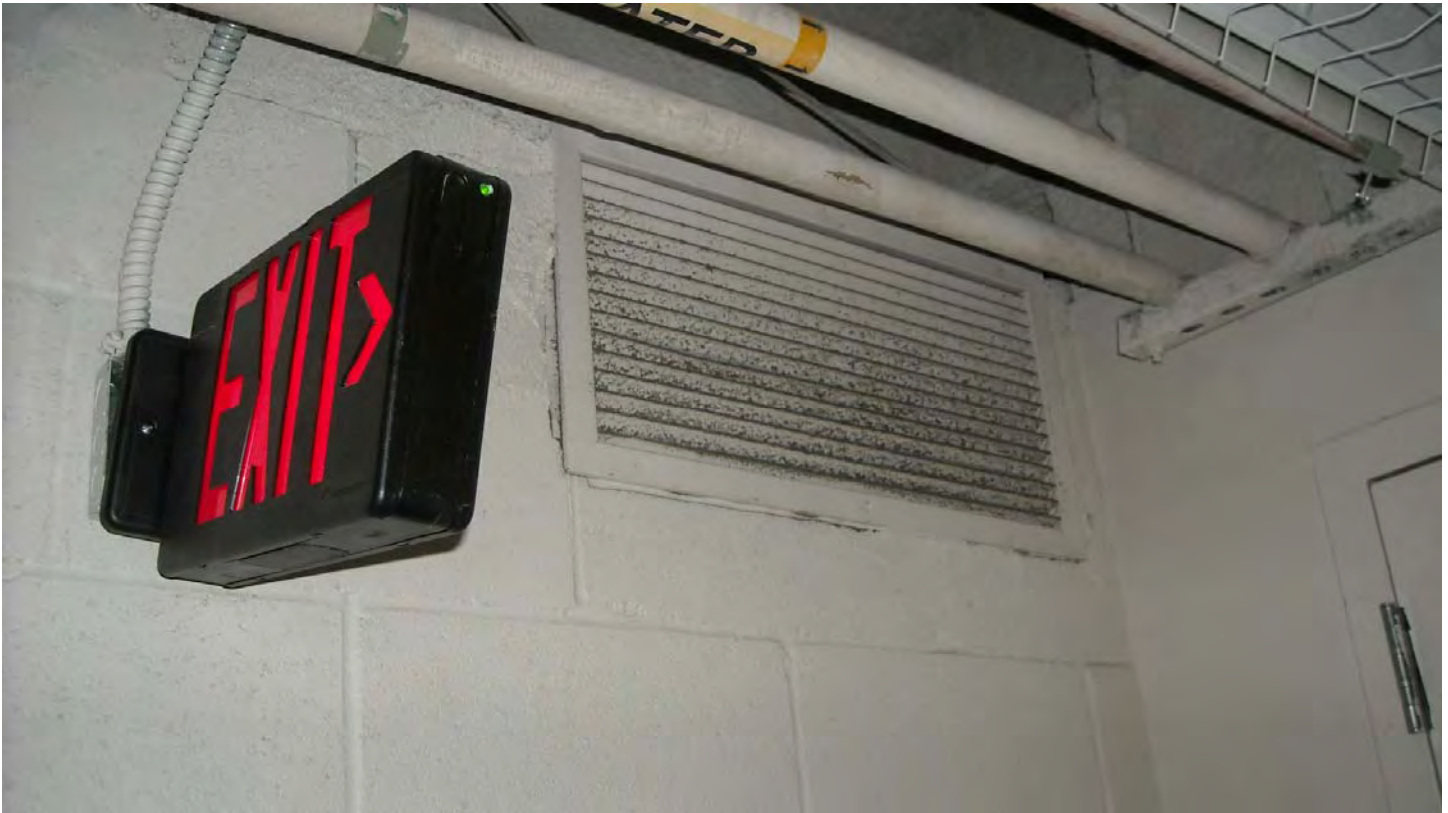
Wall registers, ceiling diffusers, and grilles show excessive accumulation of dust/debris. It is expected that similar conditions exist inside the ductwork.

Vacuum clean ducts and air terminals.

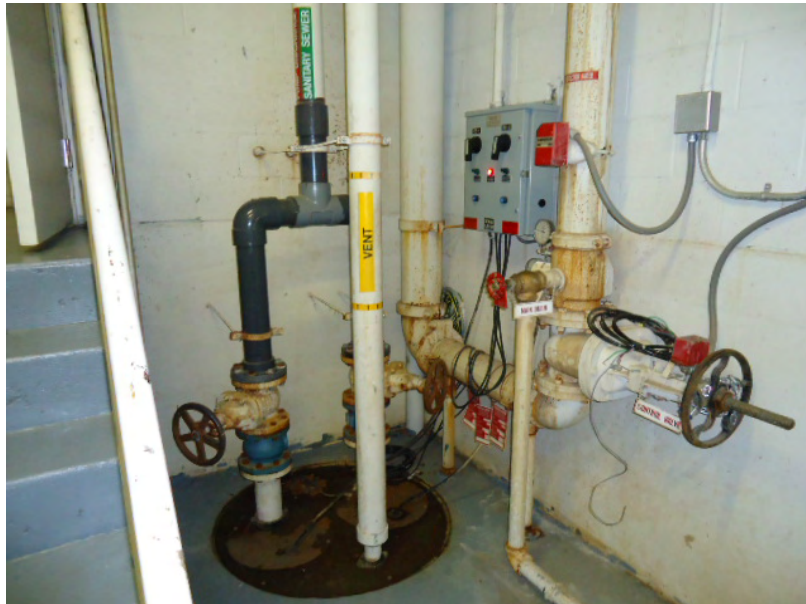
Existing Duplex Sewage Ejector Pump Located in Basement Room 056

DEFICIENCY DESCRIPTION: Malfunctioning sewage ejector producing sanitary overflow from basement floor drains.

SUGGESTED SOLUTION : During the investigation of this issue the building sewage ejector was not operating and was indicating a high water alarm. Replace existing duplex sewage ejector, control panel and basin cover. Inspect sump pit basin for damage and replace if necessary.

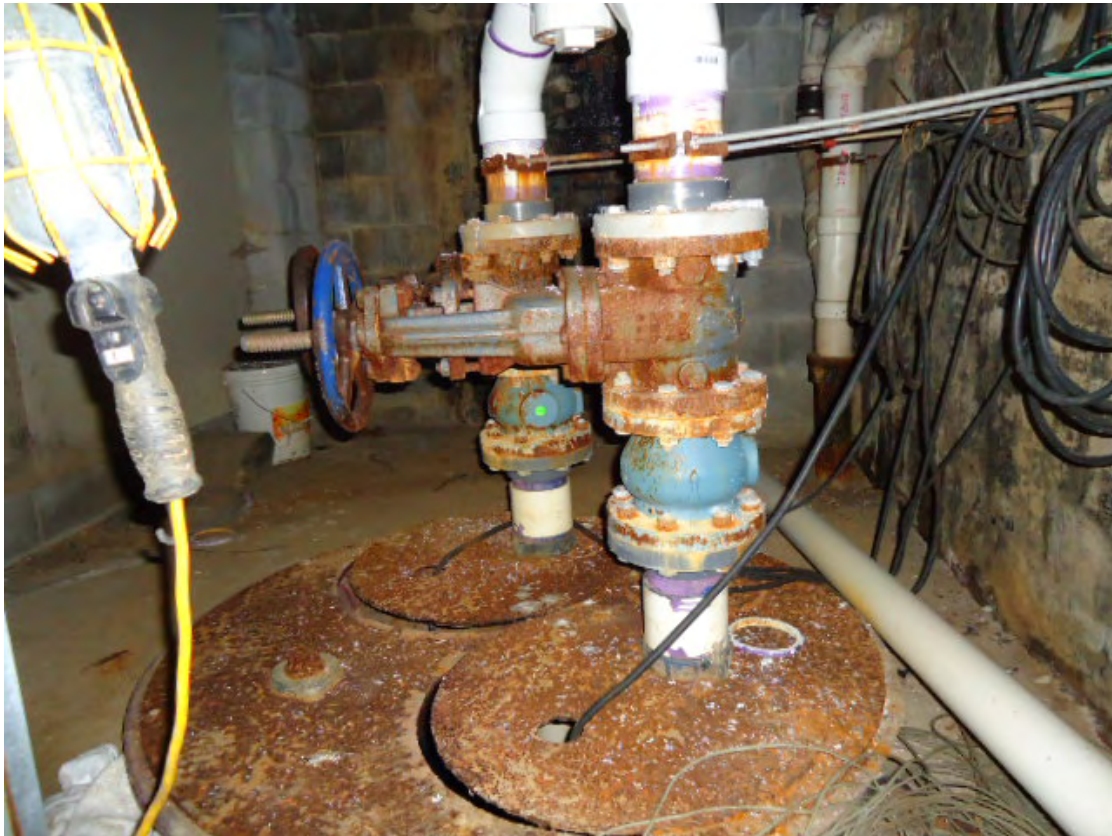
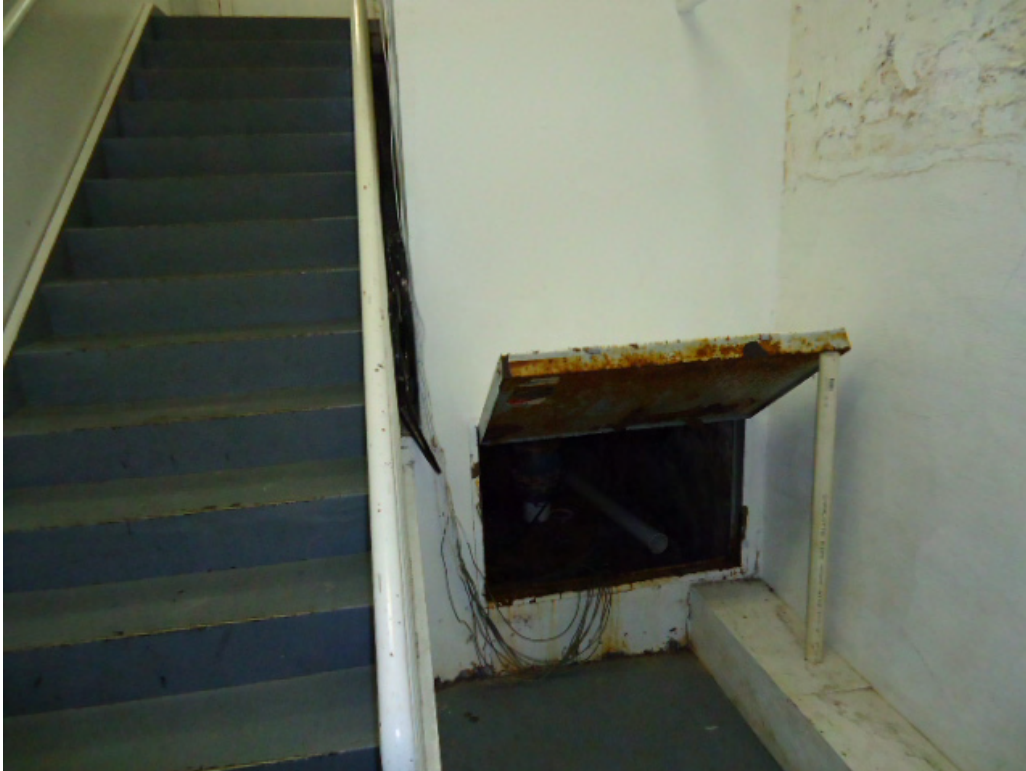
DEFICIENCY DESCRIPTION: Aged duplex sump pump system

Duplex Sump Pump (DP-1) located under stair 064

Access cover to duplex sump pump located under stair 064

Due to age it is recommend to replace existing duplex sump pump (DP-1), controls and basin cover.

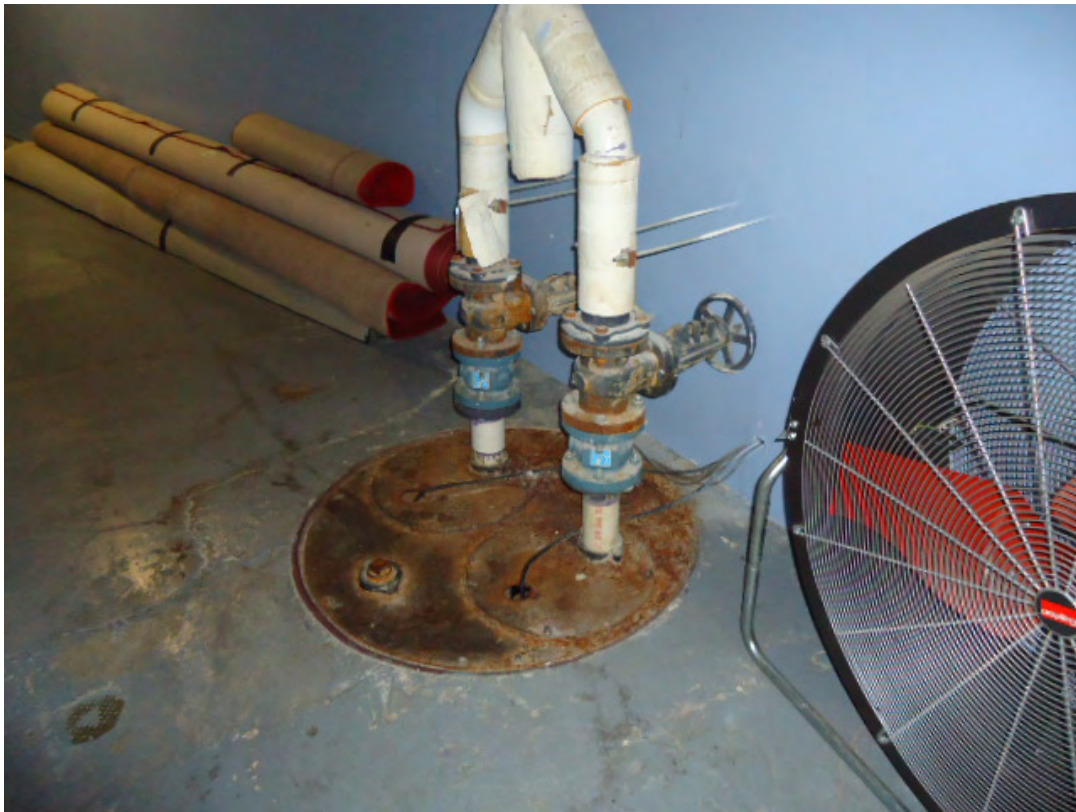
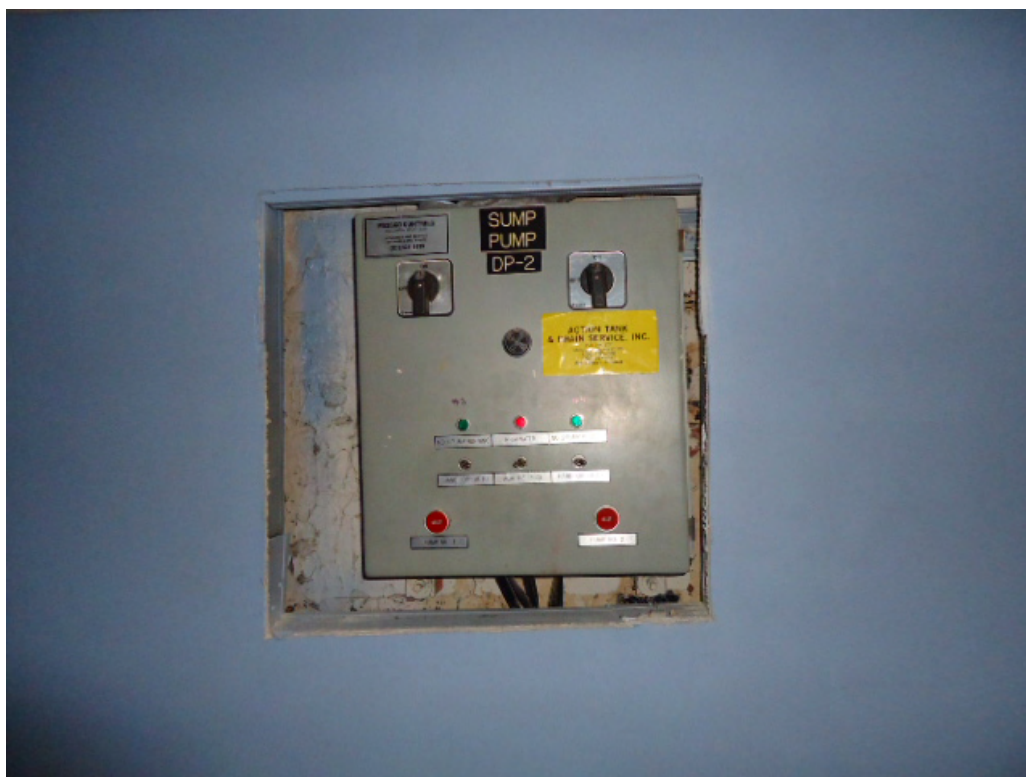
DEFICIENCY DESCRIPTION: Aged duplex sump pump system.

Duplex Sump Pump (DP-2) located in basement corridor

Duplex Sump Pump (DP-2) Control Panel

Due to age, recommendation is to replace existing duplex sump pump (DP-2), controls and basin cover.

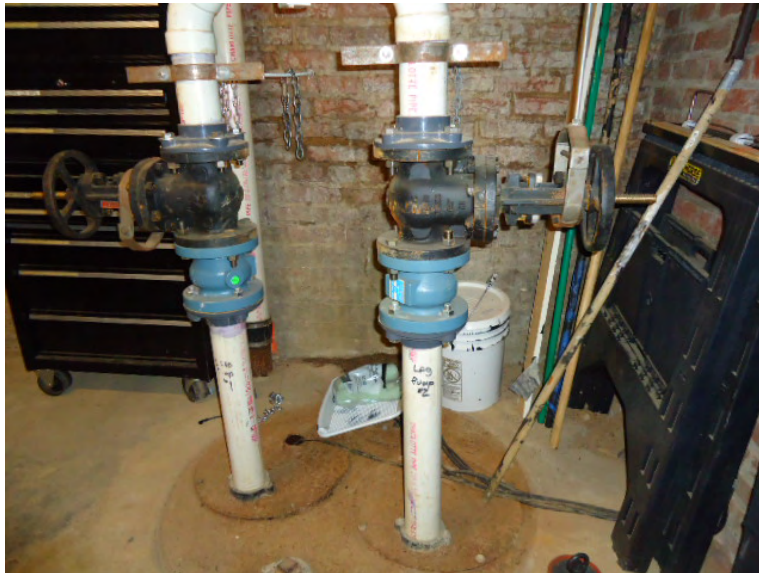
Duplex Sump Pump (DP-5) located in basement room 055

DEFICIENCY DESCRIPTION: Aged duplex sump pump system

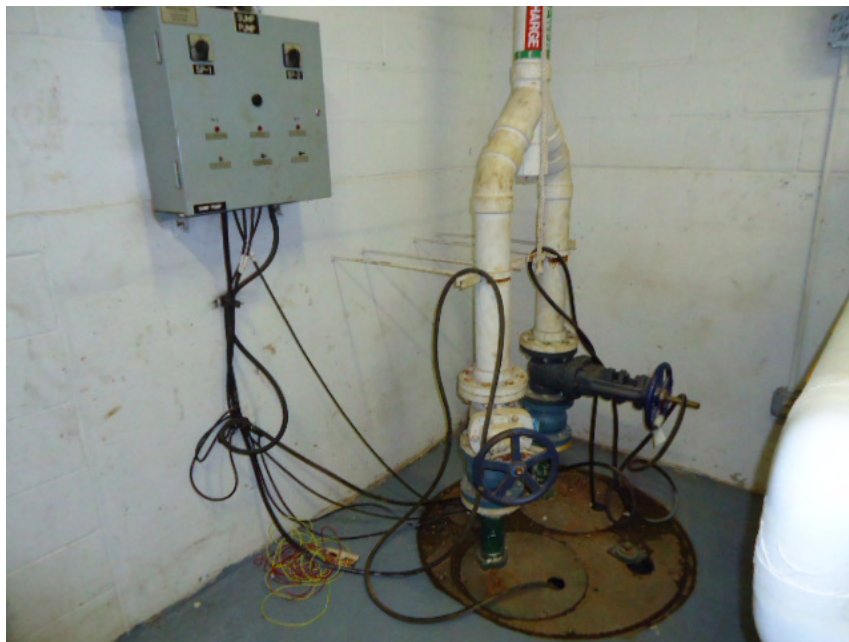
Duplex Dewatering Pump (SP-1 & SP-2) located in basement room 056

DEFICIENCY DESCRIPTION: Aged duplex dewatering pump system.

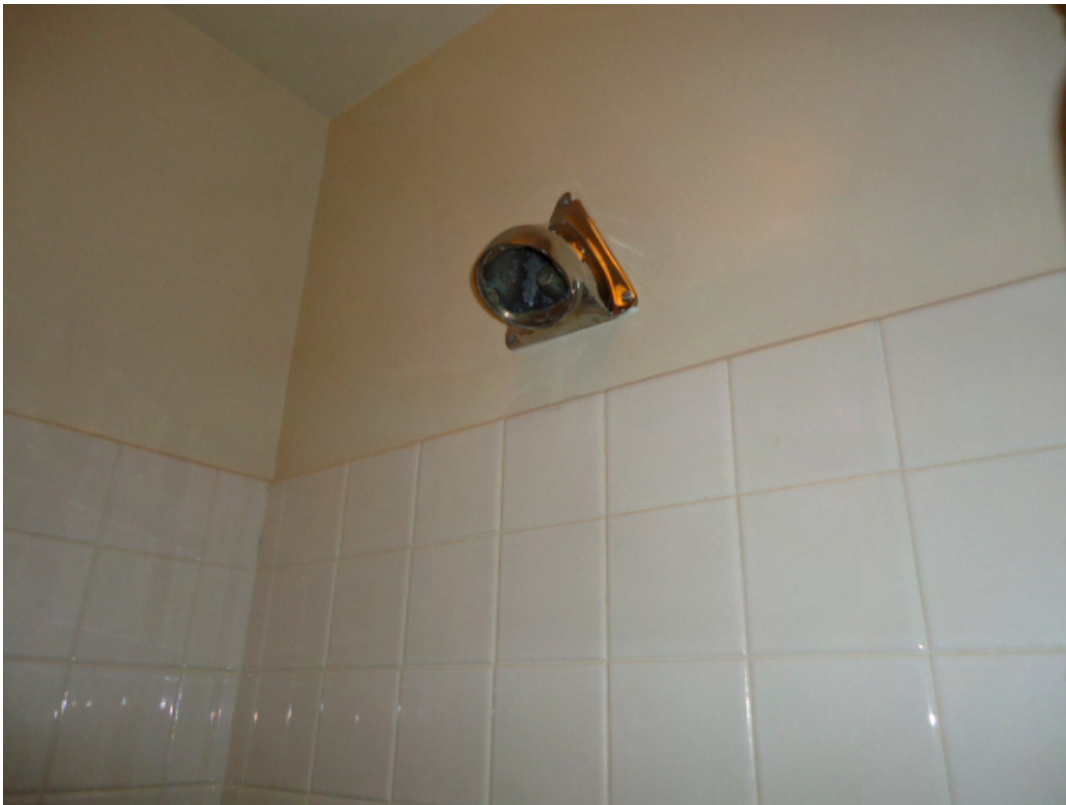
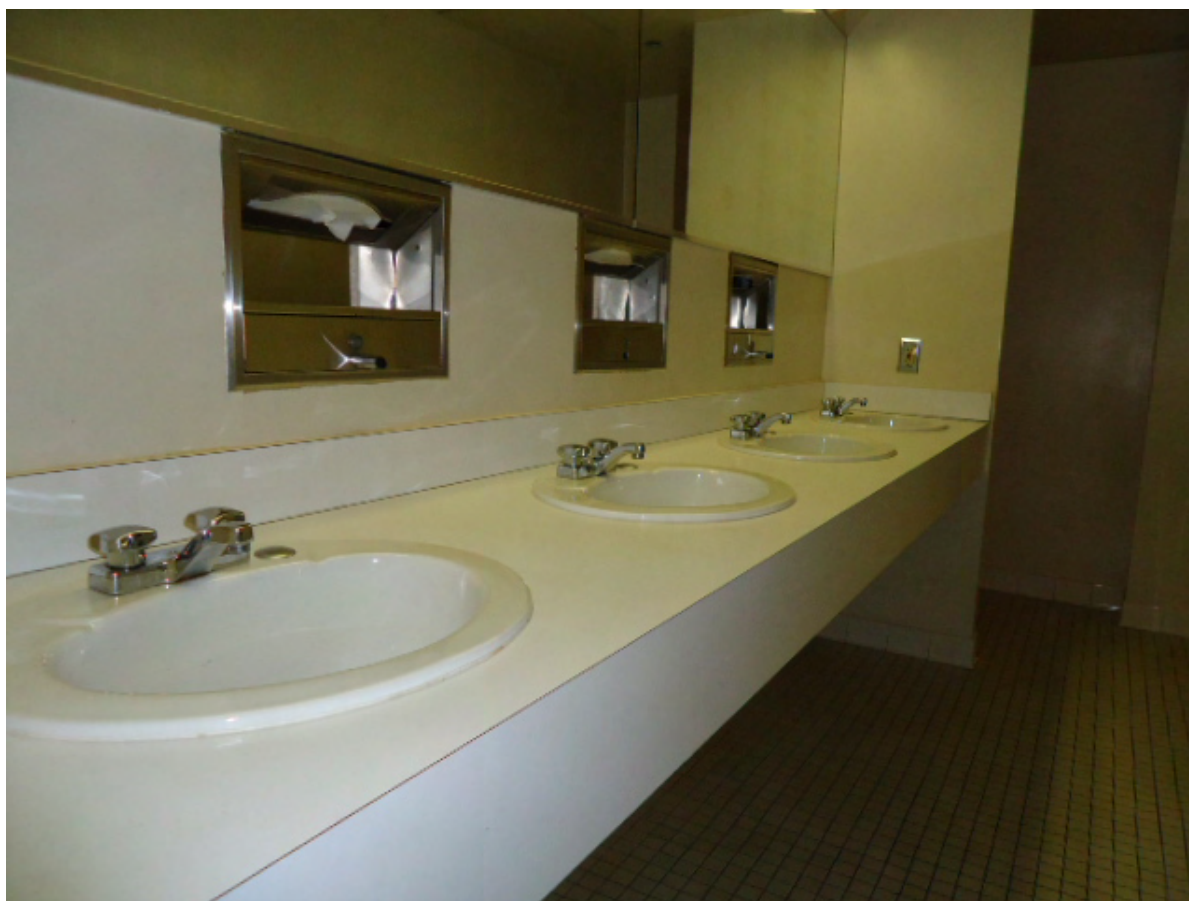
DEFICIENCY DESCRIPTION: Missing/aged showerheads and lavatory faucets.

Missing Shower Head in room 062

Typical Restroom lavatories

SUGGESTED SOLUTION : Replace all existing shower heads with new low flow type head. Replace all lavatory faucets with sensor operate. Replace all lavatory faucet aerators with low flow type aerators.

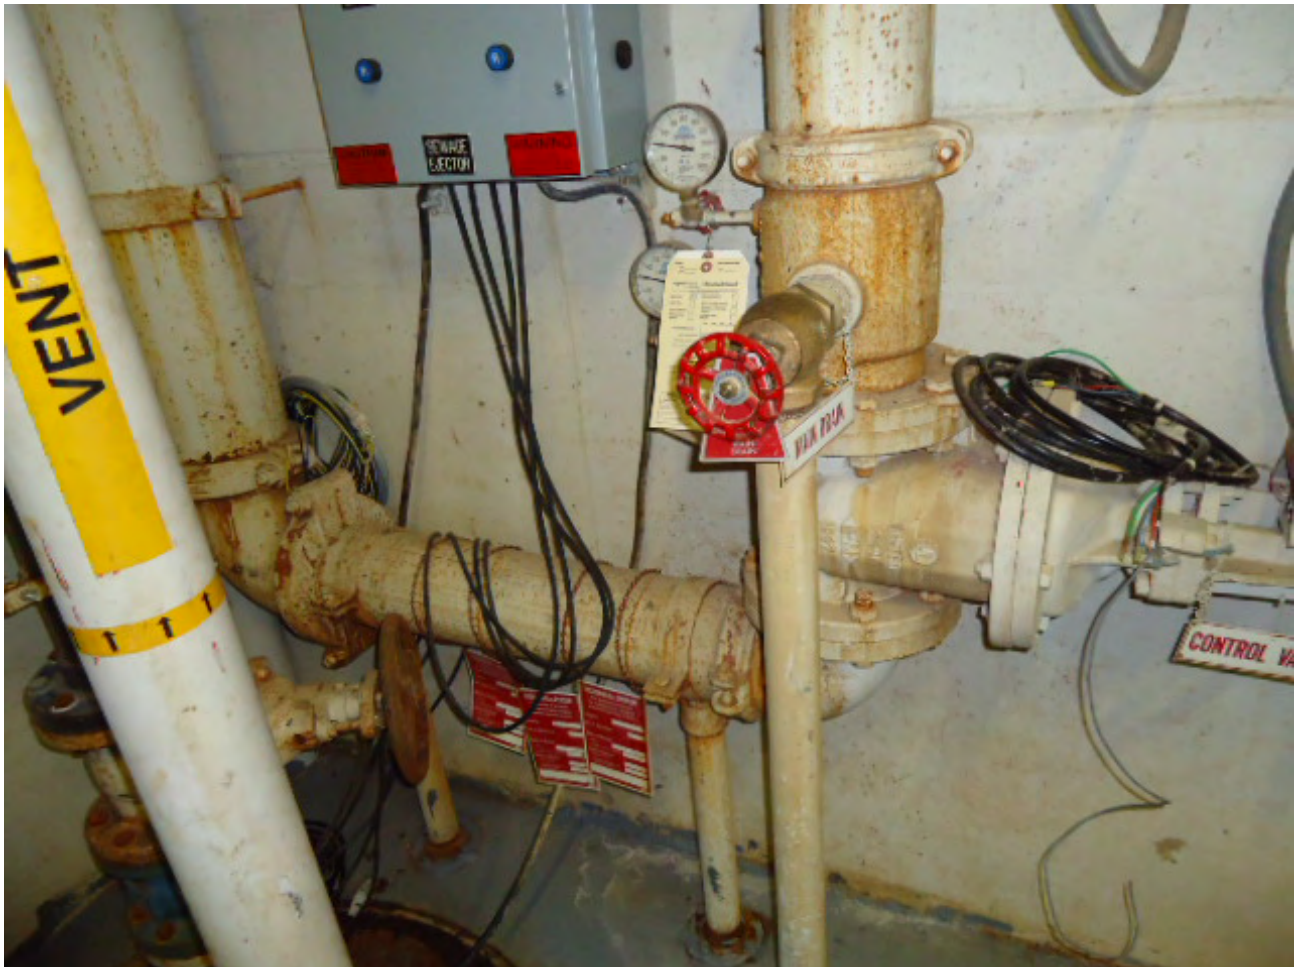
Currently the incoming fire service does not connect to a double check backflow preventer or a detector check valve.

Install backflow preventer and detector check valve.
